IED Report

BLAST-
TRACKING NUMBER: 20111114191638SMB3241 699926 DATE DISCOVERED: 2011-Nov-14 19:16

TITLE: (EXPLOSIVE HAZARD) IED EXPLOSION RPT (Directional IED) 2/B/2-325 AIR IVO (ROUTE MSR TAMPA): 1 CF KIA 2 CF WIA

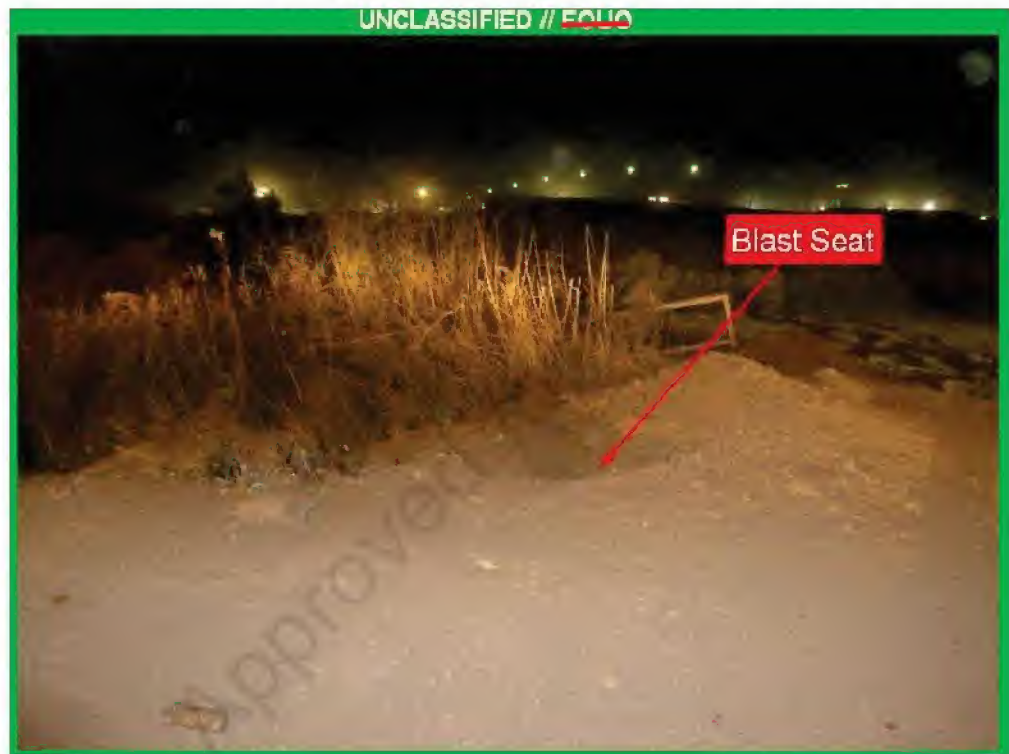
Blast Seat

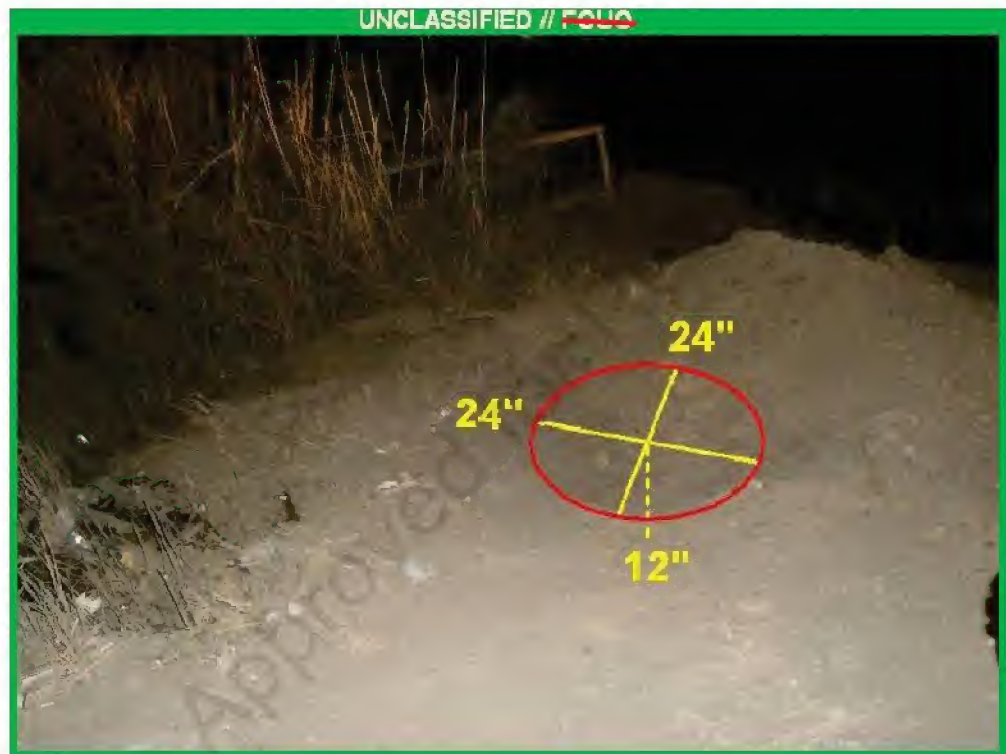
Blast Seat view from South

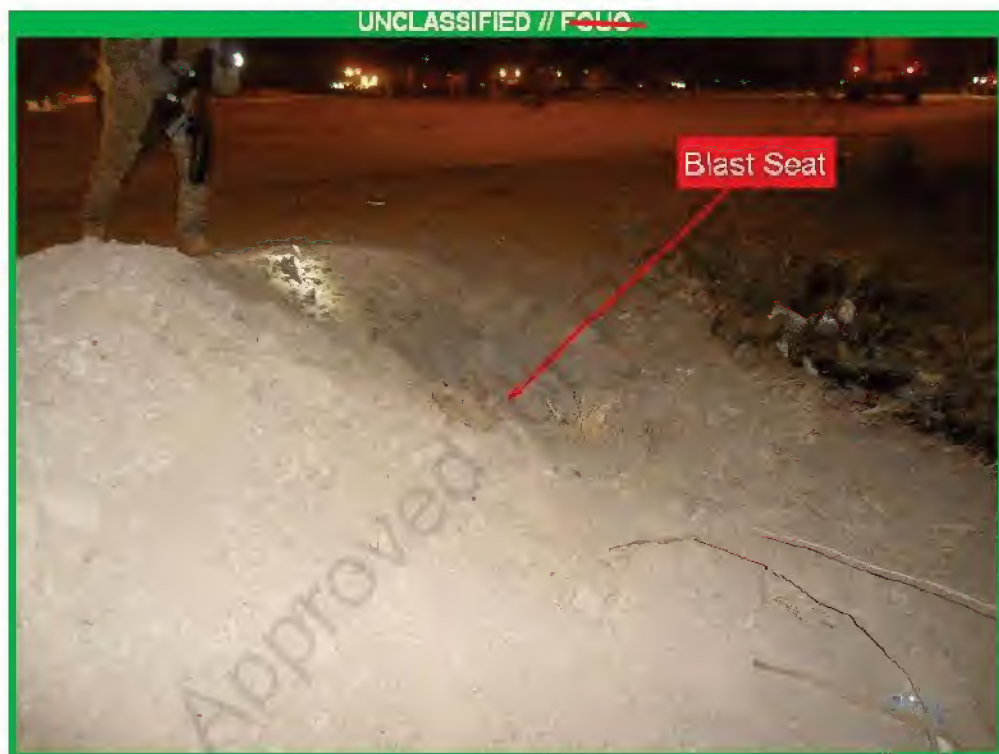
Blast Seat view from North West

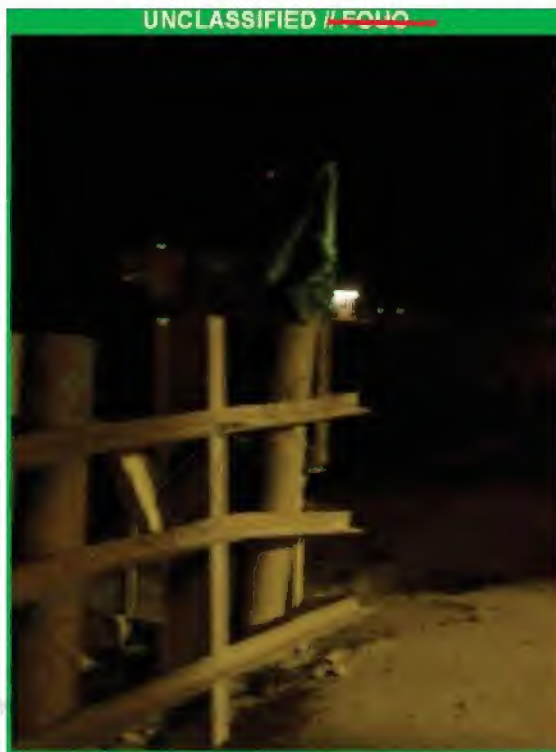
IT IS THE EOD TEAM LEADER'S ASSESSMENT THAT THE IED WAS AN EFP WITH AN UNKNOWN INITIATION SYSTEM. THE STRUCK VEHICLE WAS IMPACTED NEAR THE TOP OF THE PASSENGER SIDE INDICATING A HIGH ANGLE OF AIM, LIKELY TARGETING THE GUNNER. ALTHOUGH NO INITIATION SYSTEM WAS FOUND, THERE WAS A POLE MARKED WITH A GREEN TARP APPROXIMATELY 10M FROM THE BLAST SEAT THAT COULD HAVE BEEN USED AS AN AIMING MARKER.

Green Tarp on Pole

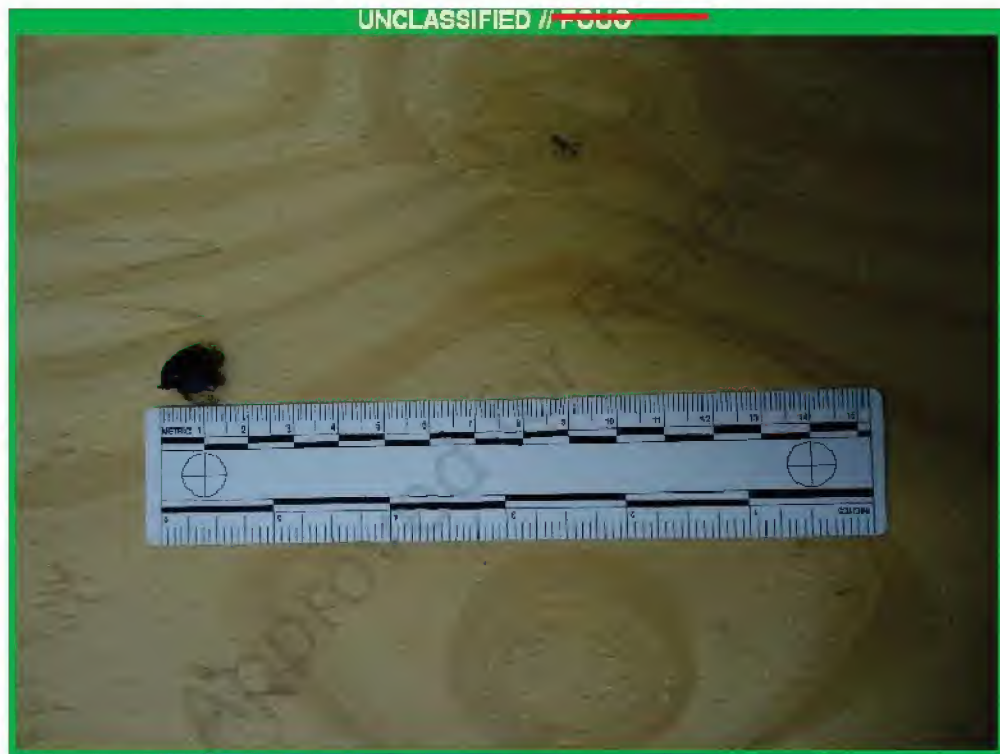
removed from inside vehicle

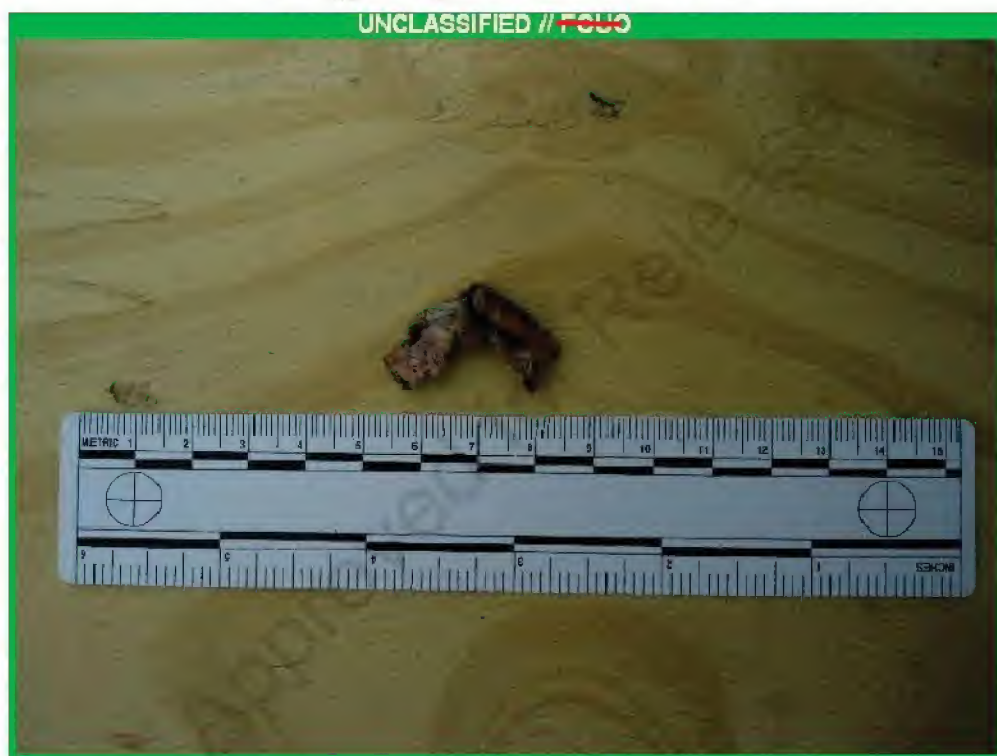
removed from inside vehicle
